Fire Headquarters
11 Church Road
Shrewsbury, MA 01545

PROJECT: TOWN OF SHREWSBURY ACCESSIBILITY PROJECT
 SHREWSBURY MAIN FIRE HEADQUARTERS
 DRAWING: FLOOR PLANS
 SCALE: 1/16" = 1'-0"
 DATE: FEBRUARY 2002

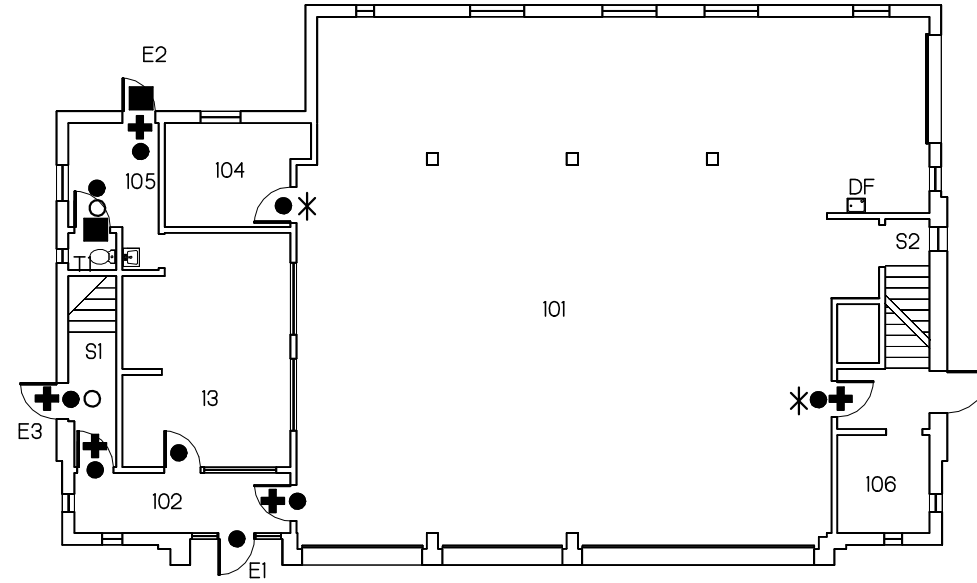
LOWER FLOOR PLAN

<i>Item</i>	<i>Action Required</i>	<i>Est. Cost</i>	<i>Priority</i>	<i>Feasibility</i>
2 doors do not have 32" clear opening	Widen doors	12,000	2	3
2 doors do not have the required clearance on the pull side	Either relocate or remove doors.	4,000	2	3
2 doors do not have the required clearance on push side	Either relocate or remove doors.	2,000	2	3
9 doors do not have hardware that is operable with a closed fist.	Replace hardware.	4,000	2	2
5 doors have closers that close too fast or are too hard to operate.	Replace or adjust closers.	2,500	2	2
